**HADITHA PRIMARY HEALTH CARE CENTER
HADITHA, IRAQ**

SUSTAINMENT ASSESSMENT

**SIGIR PA-08-134
JANUARY 28, 2009**

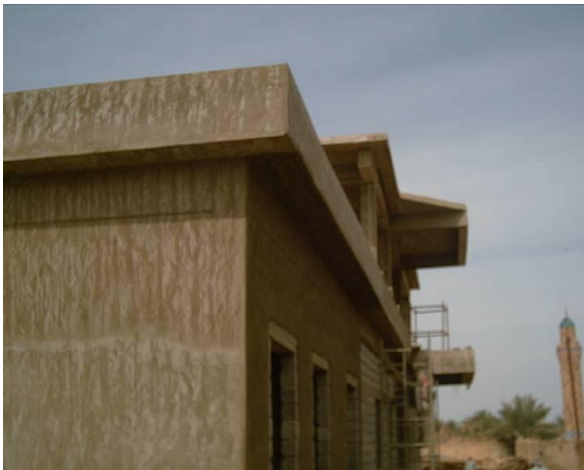
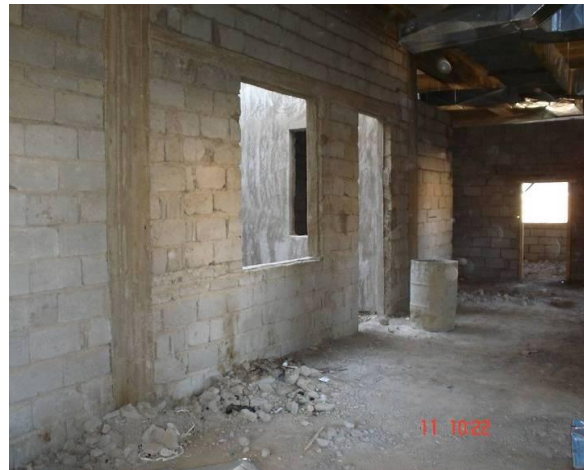
Site Photos 1 and 2. Interior and exterior views of the state of construction in March 2006
(Courtesy of GRC)

Site Photos 1-3 document the condition of the Haditha PHC when Parsons was terminated in March 2006.

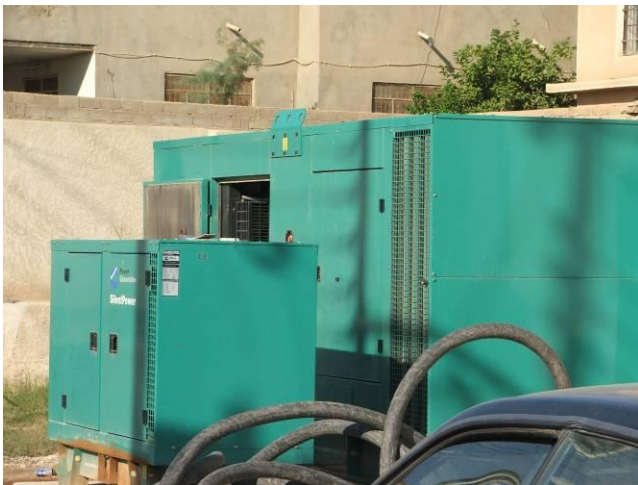
Site Photo 9. Backup generators

The Haditha PHC receives power from the national grid; however, the national grid is unreliable and provides approximately five hours of electricity per day. The remaining hours of operation are supplemented using one of the two generators located on site (Site Photo 9). In addition, a fuel storage tank was provided for the two generators (Site Photo 10). The larger generator (one megawatt) is used for primary power; while the smaller generator (500 kilovolt) is for emergency backup. Since the Haditha PHC is connected to national grid power, an automatic transfer switch is critical to instantly transfer to generator power once electricity from the national grid is lost. Any hesitation or delay in transferring power from the national grid to a generator means the facility will not have power, which could result in harm to patients undergoing procedures requiring power.

During the site visit, power from the national grid was unavailable and the facility was operating via the primary generator. However, according to the administrator, the generator's automatic transfer switch did not work, which required PHC staff to manually start the generator. Due to time limitations on site, SIGIR could not identify the cause of the automatic transfer switch's malfunction. The end result is now when power is lost from the national grid, a PHC representative has to manually switch on the generator.

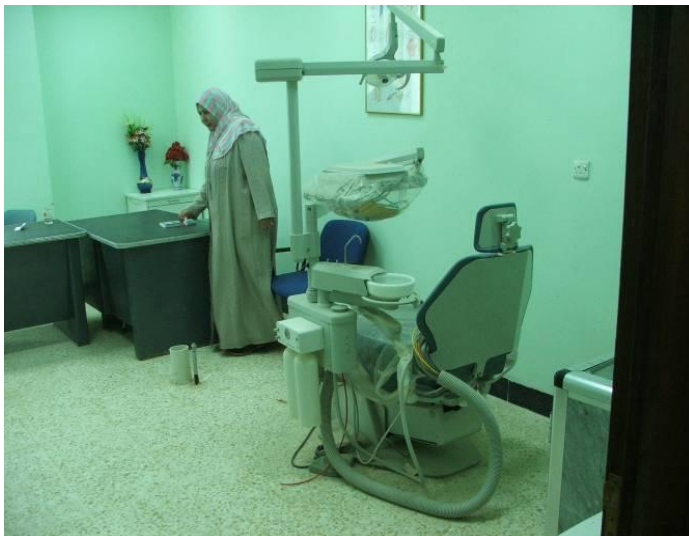
Site Photo 11. Uninstalled dental chair

During the site visit, SIGIR observed that the dental equipment, specifically the dental chair, was not installed and/or connected (Site Photo 11). According to the dentist, the chair requires connection to power, water and drain lines, and air and vacuum lines (Site Photo 12). A GRD representative stated the "PVC and Copper pipes for the dental room were missing so the dental chair was not completely installed." SIGIR noticed what appeared to be an empty junction box and conduit intended as a utility connection to the dental chair; however, it appeared that no utilities were installed in the junction box or extended to the conduit (Site Photo 13). Minor construction will be required to extend the utilities to the conduit, under the floor, and to the chair. A dental X-ray machine was installed in the clinic (Site Photo 14); however, the administrator stated that until the installation of the dental chair was complete, the X-ray machine could not be used.

The administrator stated the facility has a full time dentist; however, without the dental chair being installed and connected to purified water and drainage, there is little benefit the dentist can provide outside of very minor routine dental care.

SIGIR recommends that the Commanding General of the Gulf Region Division (GRD) perform all installation of, and training on, the medical equipment currently at the Haditha PHC, according to its prioritization listing.

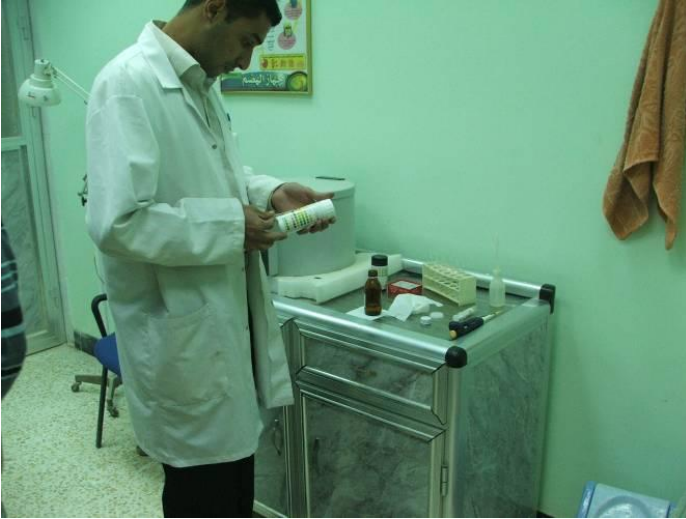
Site Photo 17. Performing lab tests

The medical laboratory appeared to be functioning. The laboratory was clean and appeared well maintained. During the site visit, SIGIR observed testing being performed (Site Photo 17). The equipment not in use was covered and appeared well organized (Site Photo 18).

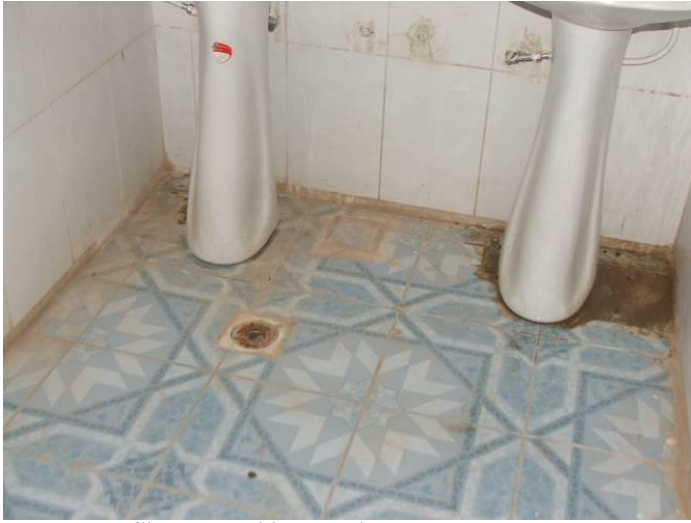
Site Photo 22. Leaking lavatory

During the site visit, SIGIR inspected a bathroom and found the lavatory was leaking (Site Photo 22). In addition, one side of the building's sewer system appeared to be blocked. The blocked sewer system made several bathrooms unusable (Site Photo 23). According to the administrator, plumbing issues were present at the time the facility was turned over to the MoH.

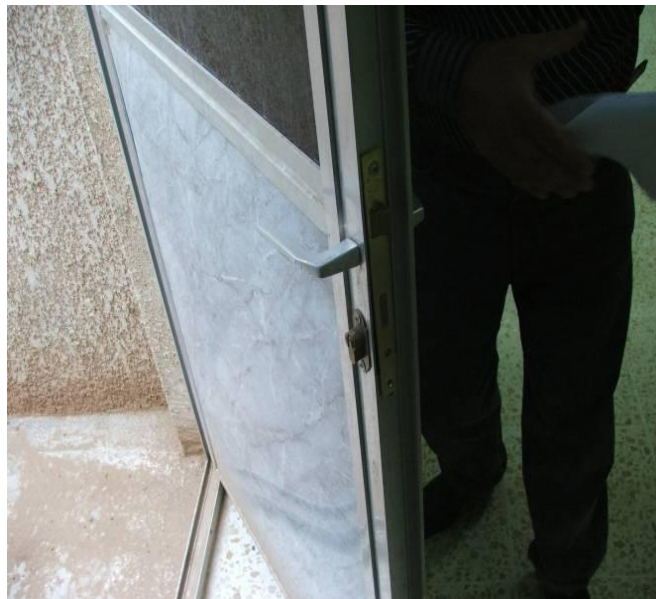
Site Photo 24. Low quality door latch

SIGIR noticed the quality of the window and door hardware was poor. Several of the window latches did not work and were not adequate to prevent unauthorized entry. For example, the administrator pointed out one specific door that could not be adequately secured (Site Photo 24).
